Assessment of Dam Safety

Coal Combustion Surface Impoundments (Task 3)

Northern States
Power Company

Sherburne County
Power Station

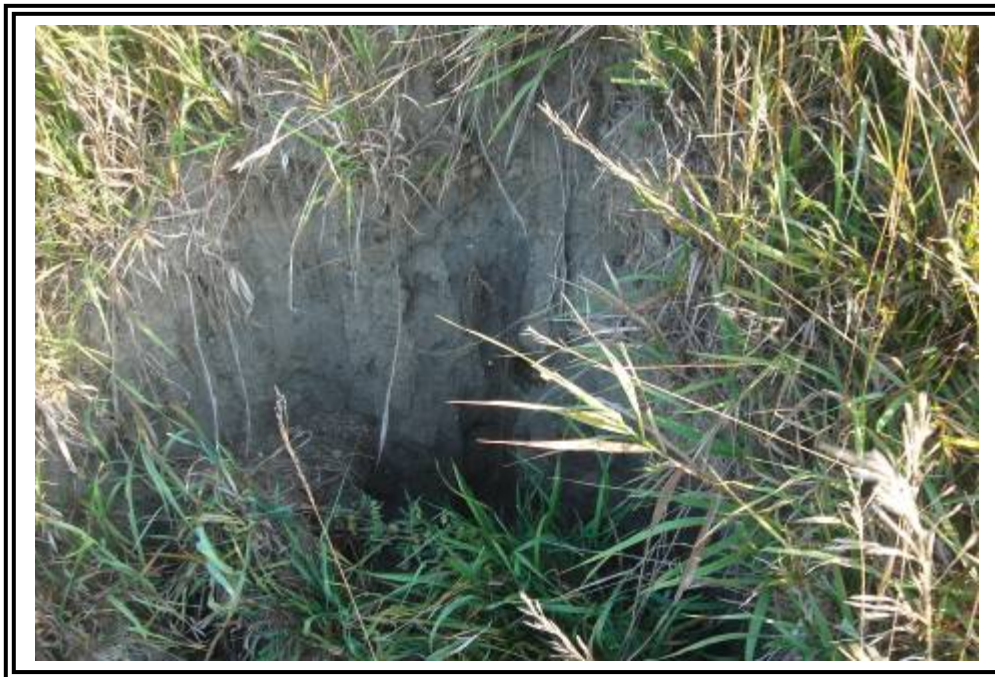
22

On the South Dam a 48-inch wide, 3-foot deep sinkhole was observed near the crest at the storm line (Photo 22). On the dam, erosion/rills were noted approximately 30 feet and 50 feet west due to crest road runoff (Photo 23). Approximately 30 feet east of southwest corner of the dam a erosion/sinkhole was observed near the crest. Numerous tree stumps greater than 4 inches in diameter were observed indicating that the trees had been recently cut.

48-inch diameter, 3-foot deep sink hole near crest of South Dam.

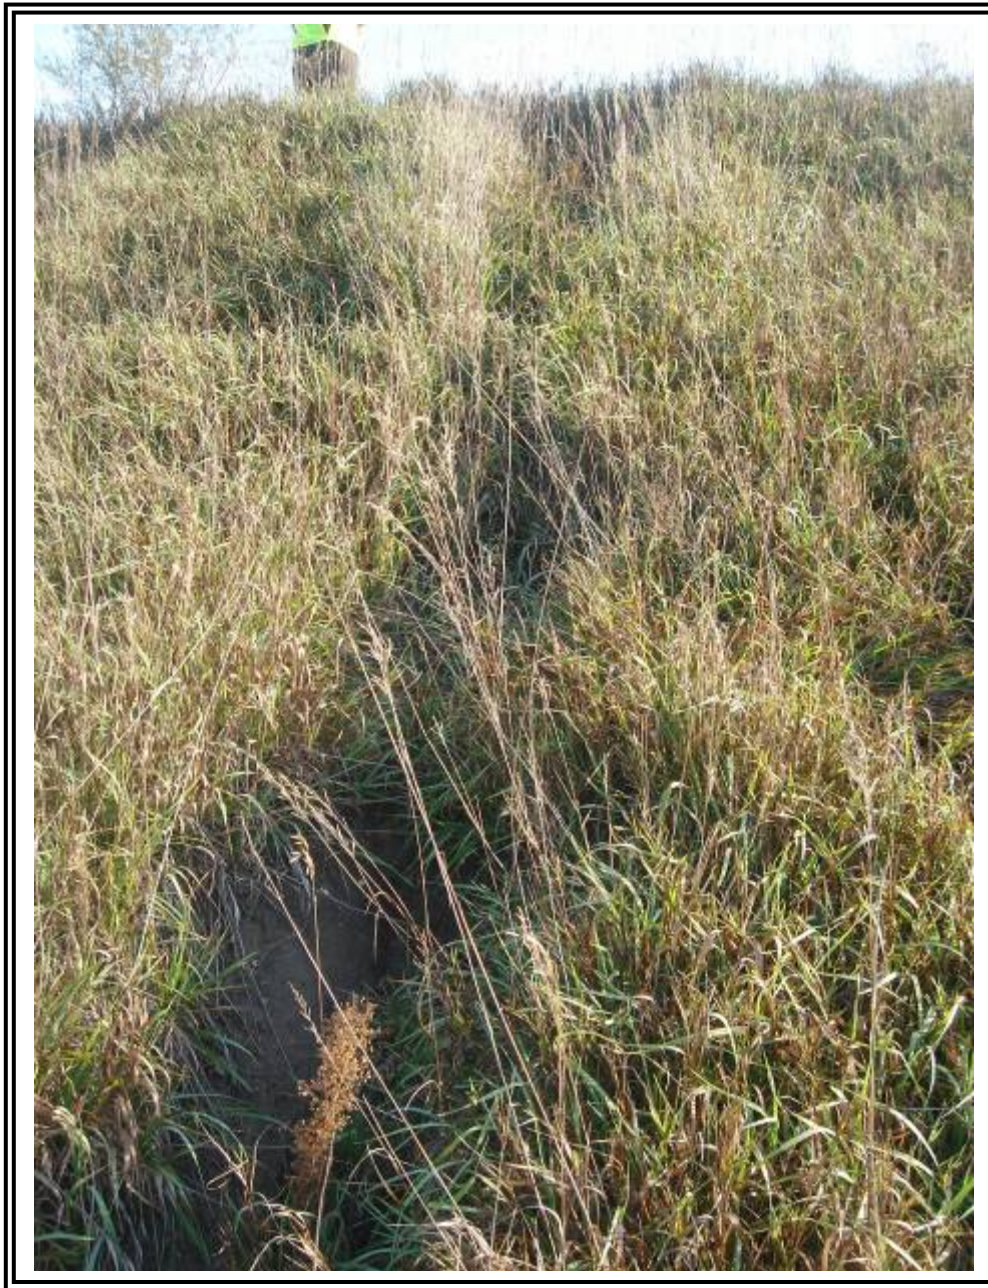
Erosion observed on downstream embankment slope of South Dam.

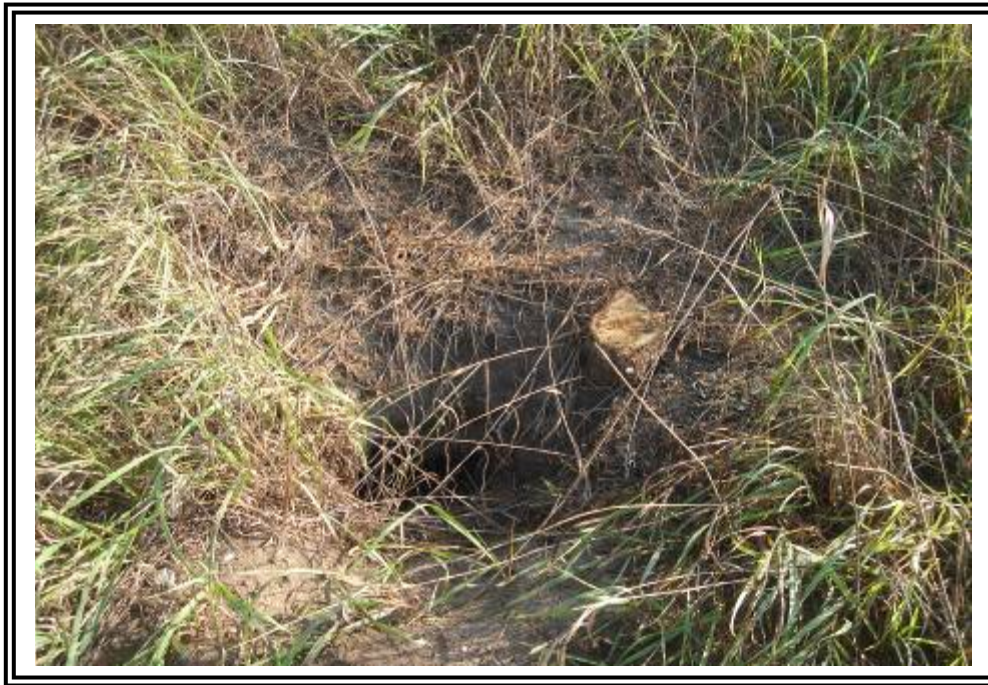
24

Animal burrows were observed on the downstream slope of the West and South Dams. On the South Dam slope approximately two-thirds the distance along the dam a 4.5-foot deep animal burrow was observed (Photo 24). In the West Dam slope surface undulations were observed possibly caused by animal burrow initiated creep.

Animal burrow on embankment slope of South Dam.

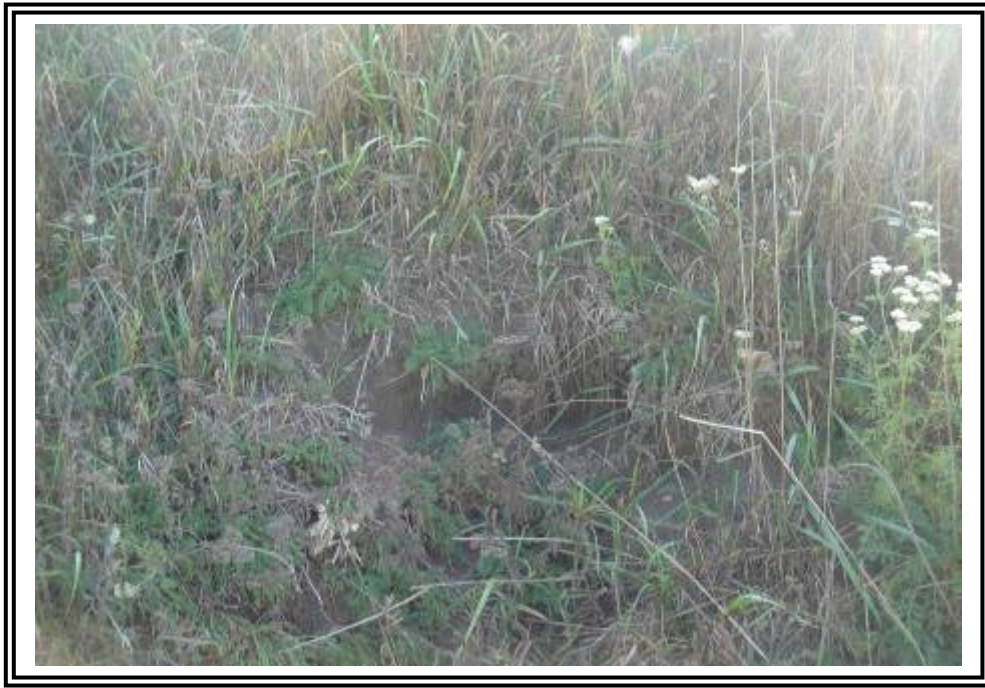
34

On the West Dam an area of minor erosion/toe scarp was observed in the ditch adjacent to the rock lined outfall ditch. Erosion was also observed at the mid-slope of the embankment and is likely due to runoff from the access road above (Photo 34). At approximately three-quarter distance from southwest corner of the dam a 6-foot wide gulley, 2-foot deep formed in surface of slope in area of surface undulation (Photos 35 and 36). This surficial slope deformation/creep is

Erosion observed at mid-height on downstream embankment slope of the West Dam.

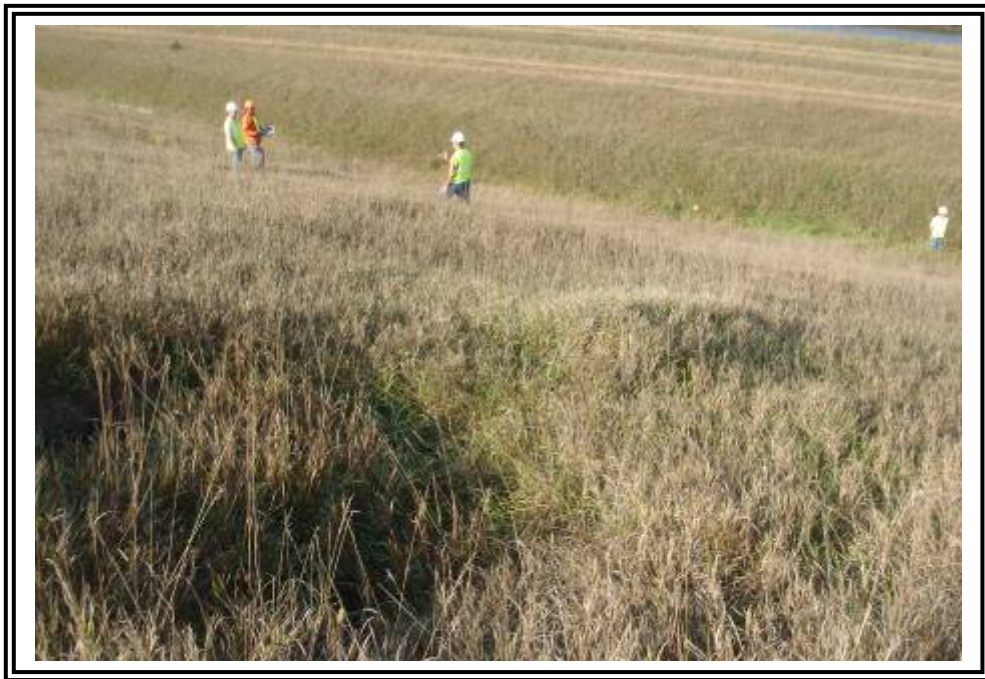
35

again likely due to substantial animal (i.e. pocket gophers, foxes, etc.) activity noted on the West Dam.

Downstream embankment slope of West Dam, facing west. Note surface undulations observed.

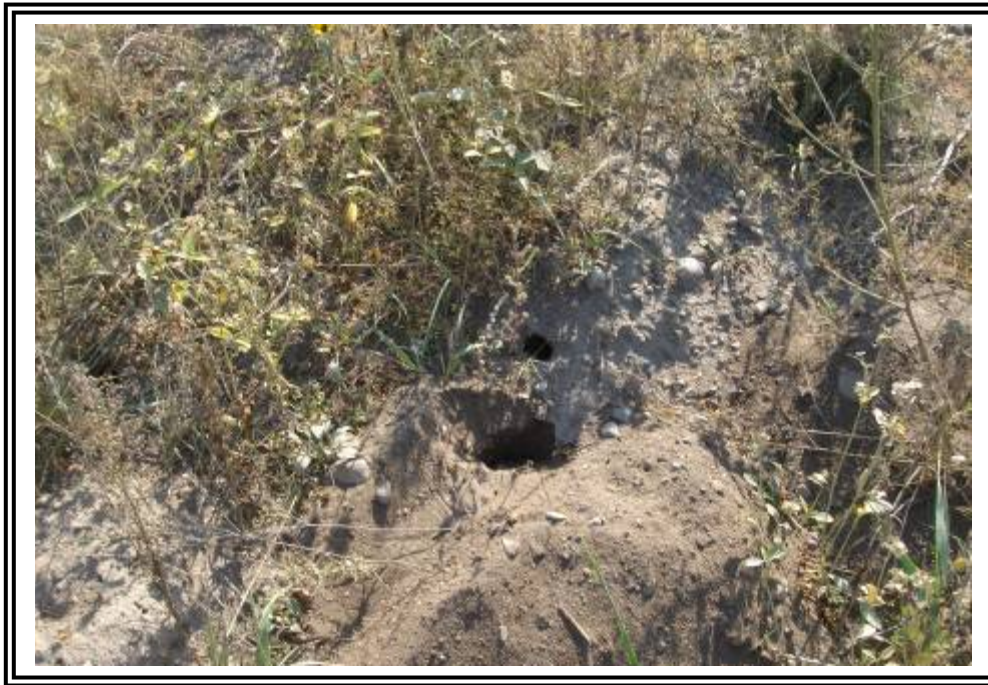
Animal burrows were noted near the crest of the North Dam and on the East Dam. The burrows were measured to be approximately 4 to 6 inches deep (Photos 41 and 42) near the crest of the North Dam.

Animal burrows on downstream embankment of North Dam.
